# ACRO ALUMINUM INC.

## TEST REPORT

Aluminum Outswing Entrance Door

105640976COQ-001Arev1

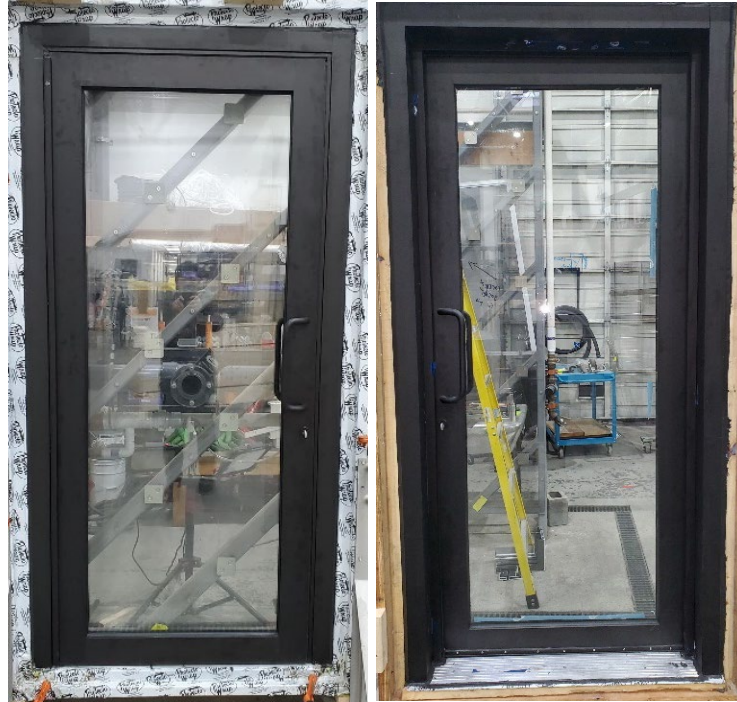
**Photo No. 1 & 2  
Outswing Side-hinged Entrance Door – Exterior, left; Interior, right**

<b>Manufacturer Information</b>	Acro Aluminum Inc. 5430 – 275 Street Langley, BC V4W 3X7 Canada
<b>Model Name</b>	<ul style="list-style-type: none"><li>Aluminum Outswing Entrance Door</li></ul>
<b>Installation</b>	<ul style="list-style-type: none"><li>Test Buck: 2x6, #2 &amp; better spf, box w/ 2x12, #2 &amp; better spf, cladding, butt joints secured with 2x #8 x 3" deck screws. The 2x12 clad was also butt jointed together with 4x #8 x 3" deck screws and secured to the 2x6 with #8 x 3" flat head screws at least at every 305 mm (12").<ul style="list-style-type: none"><li>Specimen to Buck:<ul style="list-style-type: none"><li>Head and Jamb – Aluminum 'L' angle with peel and stick membrane on the exterior side. The main profile of the head and jamb butted up to the interior side of the angle while a pressure plate was used on the exterior side to effectively clamp the profile to the angle. A length of polystyrene, cut to size, was used as a spacer. The pressure plate was secured in place using 1/4" x 3/4" pan-head stainless steel bolts spaced approximately every 229 mm (9") o.c.</li><li>Sill – The sill plate was in 2 parts. The main sill profile was secured using 3x #8 x 1-1/2" flat-head screws and the interior cover plate was secured using 3x #10 x 1-1/2" flat-head screws.</li></ul></li><li>Silicone was used to seal all screw heads and the joints of the test buck as well as the rough opening of the buck on the interior and exterior sides of the head and jambs. The sill joint to the jambs and the interior edge to the buck was sealed.</li></ul></li></ul>

<b>Size</b>	<ul style="list-style-type: none"><li>Overall Size:<ul style="list-style-type: none"><li>Width: 1070 mm (42.1")</li><li>Height: 2210 mm (87.0")</li></ul></li></ul>
<b>Frame</b>	<ul style="list-style-type: none"><li>Material: Aluminum with thermal break</li><li>Corners: Butted and mechanically fastened at the head</li><li>Reinforcement: None.</li><li>The head and jamb profiles were assembled together in 4 parts. The main rectangular tubing with a thermal break to the screw chase track for the pressure plate. An extruded aluminum clamp rail for the pressure plate, secured to the main profile using closed cell foam tape and #8 x 1-1/2" pan-head stainless steel self-taping screws, with 5x along the jambs spaced approximately every 330 mm (13") to 432 mm (17") o.c. apart and 3x along the head, one at each end and at mid-span. A snap-in plastic cover was used for the 'inside' surface of the rail which allowed for a 2-part snap-in extruded aluminum stop for the operable panel. The plastic cover along the hinge jamb was also secured in place using 9x #8 x 3" flat-head screws.</li></ul>

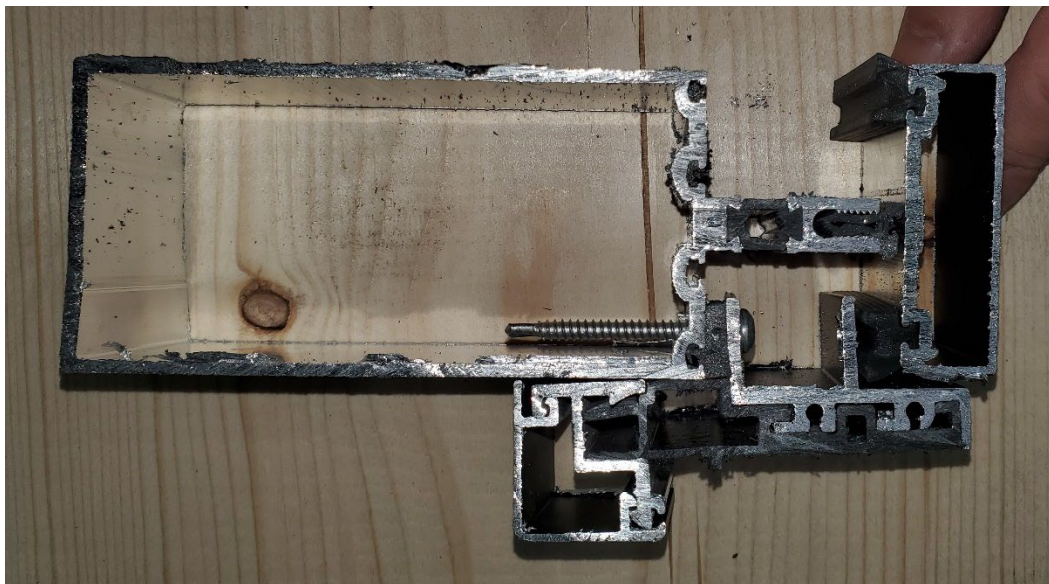
**Photo No. 3  
Frame Assembly Profile**

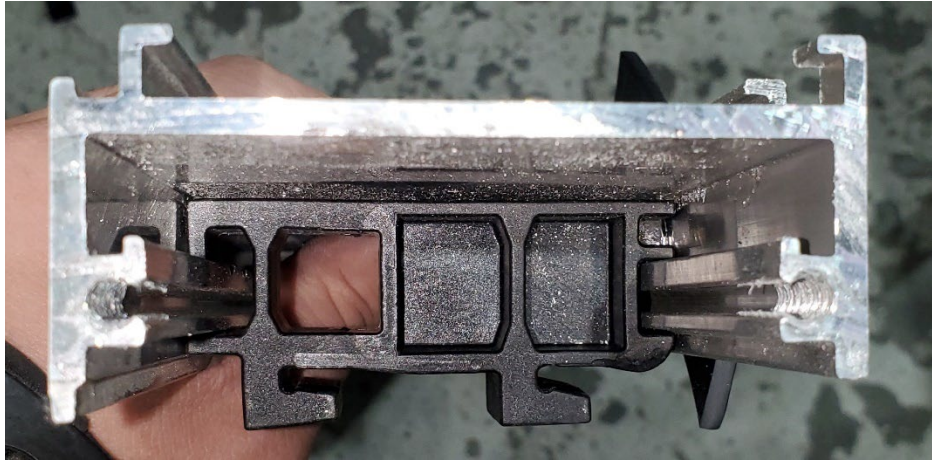
**Photo No. 4**  
**Panel Profile**

<b>Operable Panel</b>	<ul style="list-style-type: none"><li>• Material: Aluminum</li><li>• Corners: Butted and mechanically fastened</li><li>• Reinforcement: None.</li><li>• Panel Size:<ul style="list-style-type: none"><li>• Width: 903 mm (35.6")</li><li>• Height: 2118 mm (83.4")</li></ul></li><li>• A snap and slide in cover was used on the interior and exterior sides of the profile. The cover snaps into a number of plastic mounting blocks that slide within the profile; 3x blocks for the top and bottom rails per side; 8x blocks for the stiles per side.</li></ul>
<b>Locks and Hardware</b>	<ul style="list-style-type: none"><li>• Single handle approximately 1105 mm (43-1/2") o.c. up from the bottom of the lock stile.</li><li>• Single deadbolt lock hook with the keeper slot approximately 800 mm (31-1/2") o.c. up from the bottom of the lock jamb.</li><li>• Full length hinge, secured in place using 19x, into the panel and jamb, 6 mm x 3/4" flat-head screws (with painted heads):<ul style="list-style-type: none"><li>• In 3x sets of pairs at the top and bottom ends of the hinge, 32 mm (1-1/4") from the ends and 83 mm (3-1/4") apart.</li><li>• Between the top and bottom pairs, in a zig-zag pattern, approximately 203 mm (8") to 254 mm (10") o.c. apart.</li></ul></li></ul>

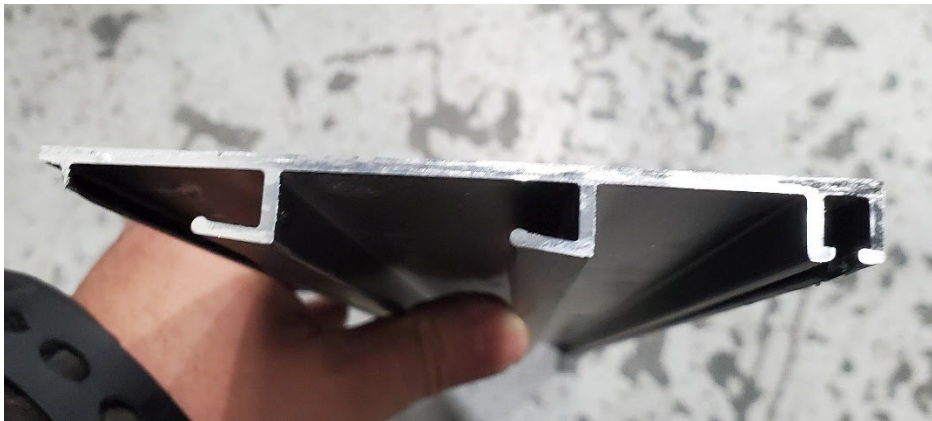
**Photo No. 5**  
**Panel Cover**

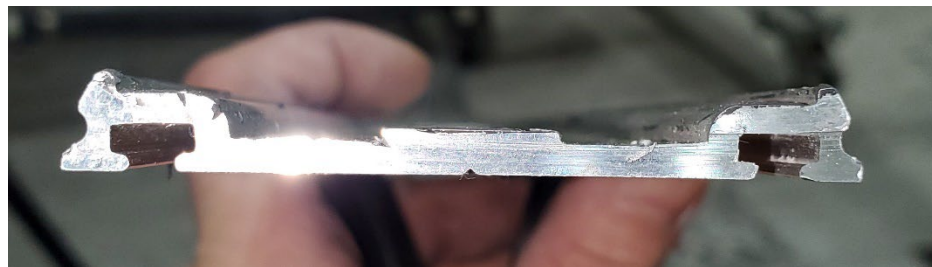
**Photo No. 6**  
**Pressure Plate**

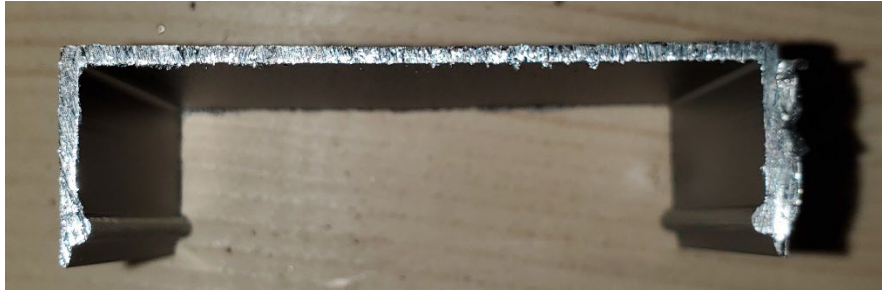
**Photo No. 7**  
**Pressure Plate Cover**

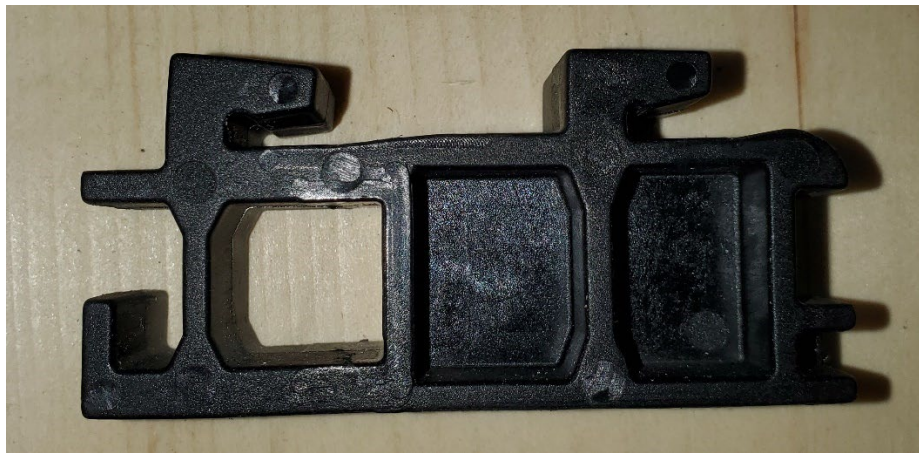
**Photo No. 8**  
**Exterior Side Mounting Block for Panel Cover**

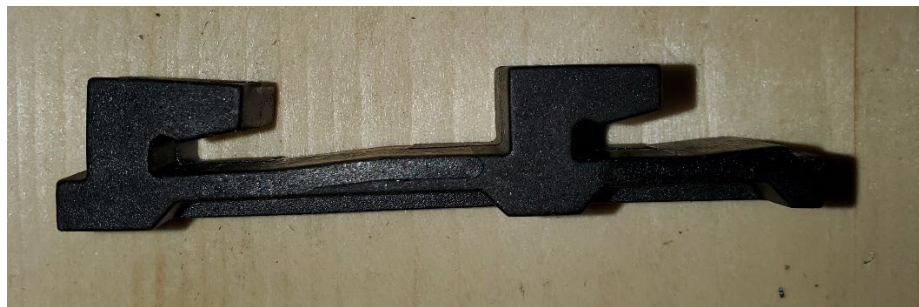
**Photo No. 9**  
**Interior Side Mounting Block for Panel Cover**

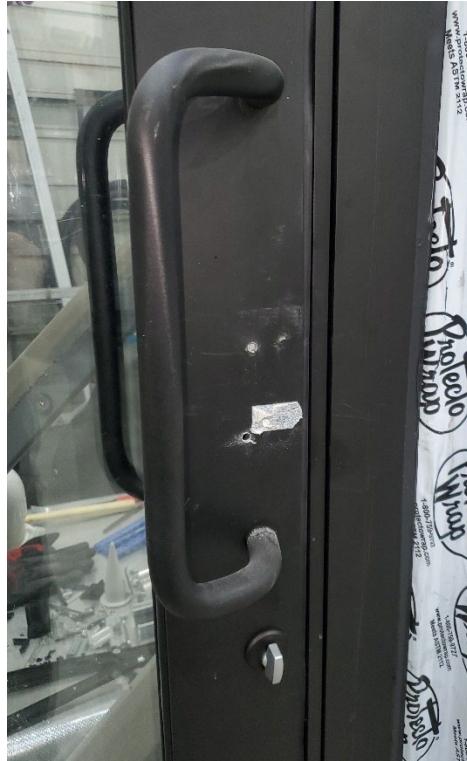
**Photo No. 10**  
**Handle**

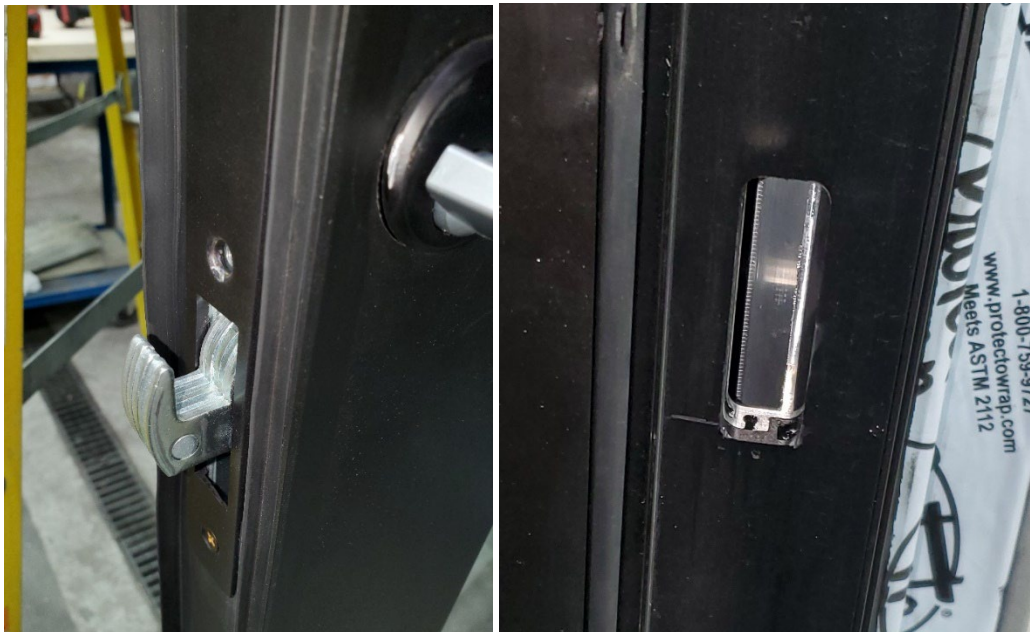
**Photo No. 11 & 12**  
**Hook Lock, left; Keeper Slot, right**

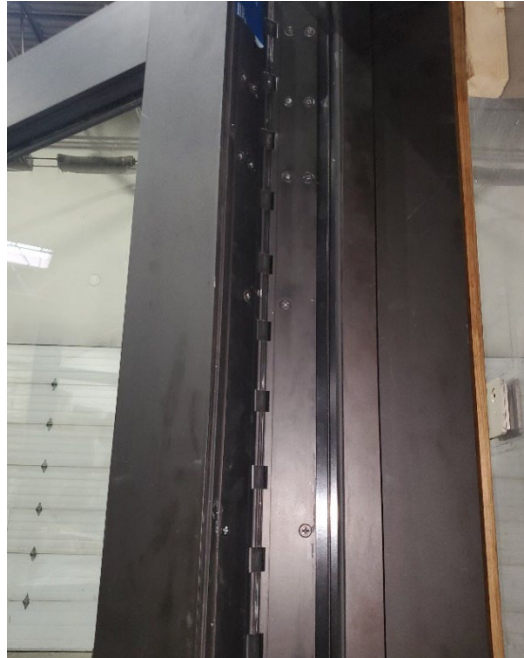
**Photo No. 13**  
**Full Length Hinge**

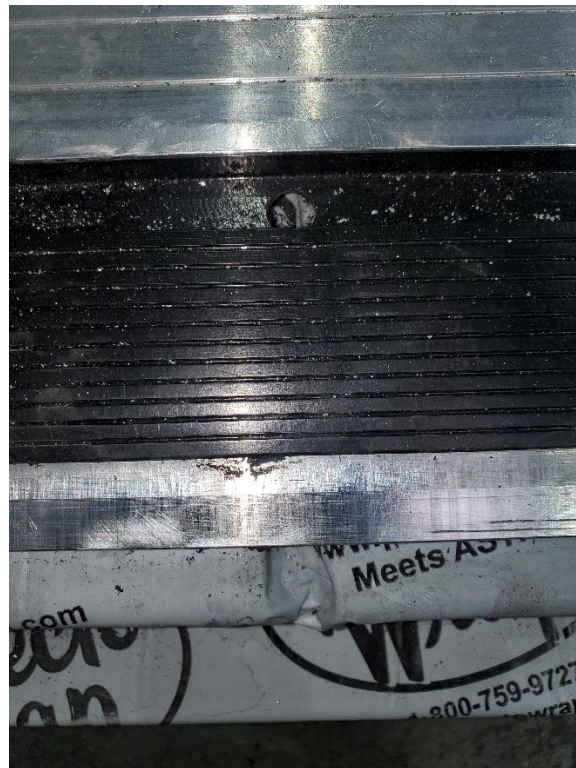
**Photo No. 14**  
**Sill Drainage**

<b>Drainage</b>	<ul style="list-style-type: none"><li>• 3x drain holes, 8 mm (5/16") diameter, into through the sill approximately 51 mm (2") o.c. from the lock jamb, 102 mm (4") o.c. from the hinge jamb and at the mid-span between the 2. Notches were cut into the test buck to provide a drainage channel for these 3 drain holes.</li><li>• Glazing cavity drains out through a notch cut into the bottom rail at the corners.</li></ul>
<b>Weather-strip</b>	<ul style="list-style-type: none"><li>• The frame has an exterior bulb gasket along the head and jambs.</li><li>• An EPDM gasket was used around the perimeter to cap the sides of the panel. The gasket covers the full depth of the panel with a fin along both the interior and exterior edge. Along the hinge side, the interior fin was trimmed off to allow the hinge to sit flush. Along the top and bottom rail, the gasket was also secured with 2x #8 x 1-1/2" flat-head screws</li><li>• Face mounted to the bottom edge of the door panel was an EPDM gasket held in place with an aluminum bar that was secured with 9x #8 x 5/8" pan-head stainless steel self-taping screws that were spaced approximately every 102 mm (4") o.c. The mounting bar was seal to the door panel with silicone.</li><li>• A compression gasket was used along both length edges of the pressure plate. A length of gasket was also used for the screw chase on the frame.</li></ul>

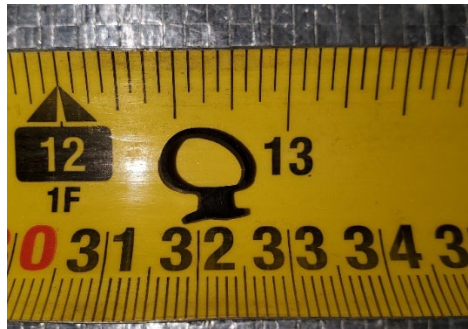
**Photo No. 15**

**Head and Jamb Frame Weather-strip**

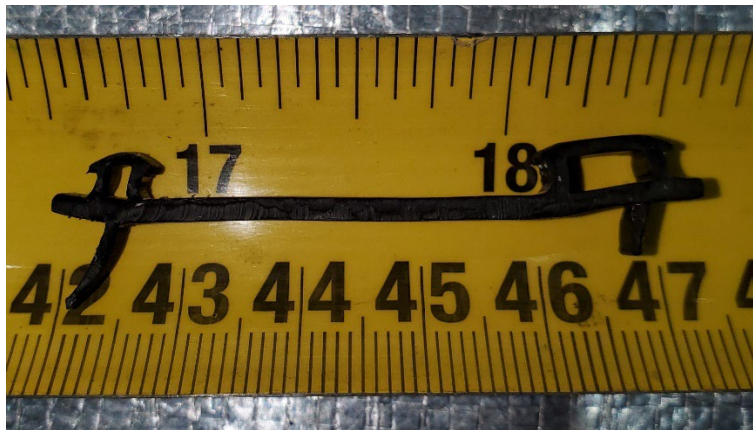
**Photo No. 16**

**Panel Side Profile Cap Weather-strip**

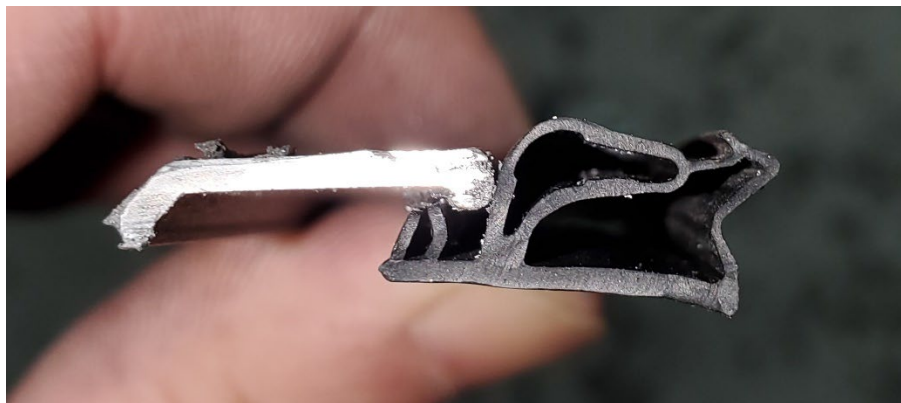
**Photo No. 17**

**Panel Bottom, Face Mounted Weather-strip**

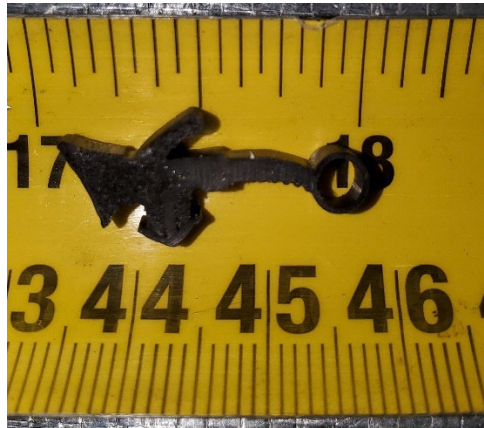
**Photo No. 18**  
**Glazing Gasket**

<b>Glazing</b>	<ul style="list-style-type: none"><li>• IGU specification:<ul style="list-style-type: none"><li>• 6 mm / 6 mm clear tempered lites with 13 mm spacer bar</li><li>• Overall thickness, 25 mm (~1")</li></ul></li><li>• Laid-in, exterior glazed on top of a glazing gasket on the panel profile.</li><li>• Glazing Blocks: 4x sets of rubber setting blocks of various thicknesses, 1x on each side.</li><li>• Glazing Stops: Aluminum snap and slide cover with push-in gasket.</li></ul>
<b>Drawings</b>	<ul style="list-style-type: none"><li>• A copy of the drawing package supplied by Baywest Glazing Systems Inc. is included in Section 10 of this report.</li></ul>

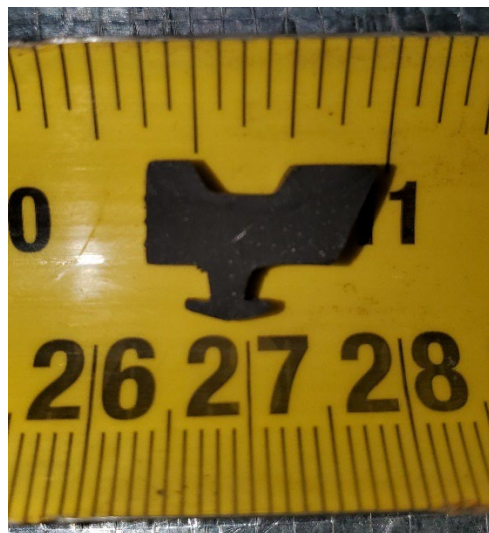
**Photo No. 19**  
**Pressure Plate Gasket**
