ACRO ALUMINUM INC.

TEST REPORT

Aluminum T451 Storefront 4-Lite Fixed Combination Window

105479267COQ-001C

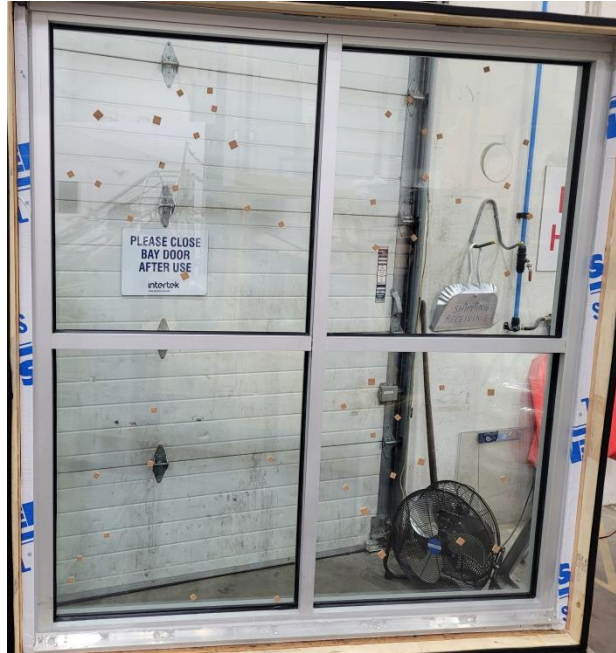
Photo No. 1

Aluminum T451 Storefront 4-Lite Fixed Combination Window - Interior

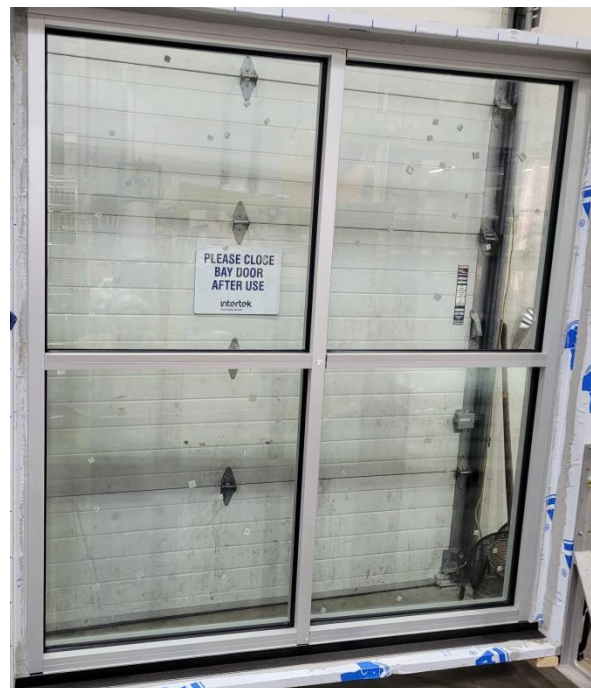
Photo No. 2

Aluminum T451 Storefront 4-Lite Fixed Combination Window - Exterior

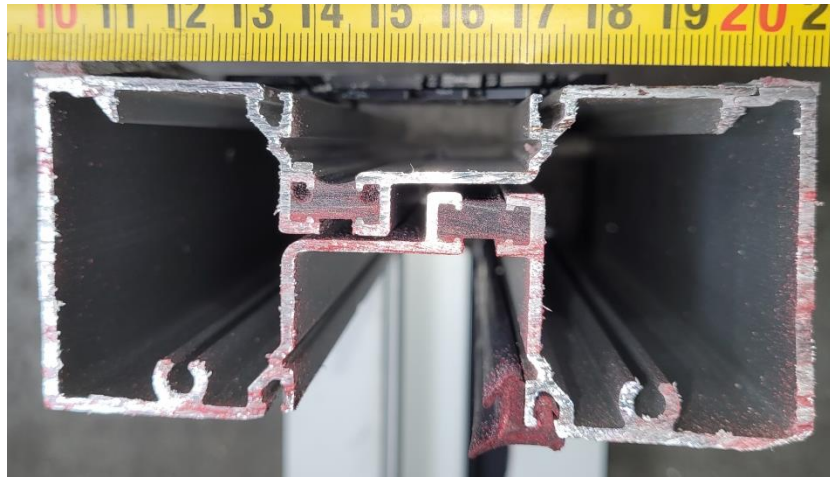
Photo No. 3
Jamb assembly

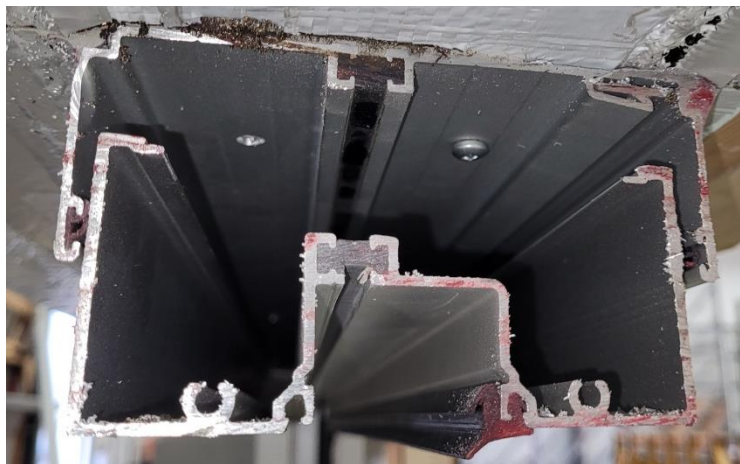
Photo No. 4
Head assembly

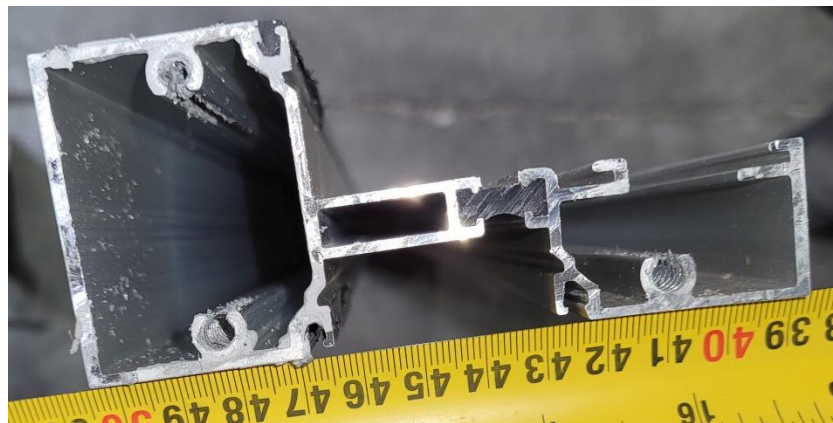
Photo No. 5
Sill and Horizontal Mullion assembly

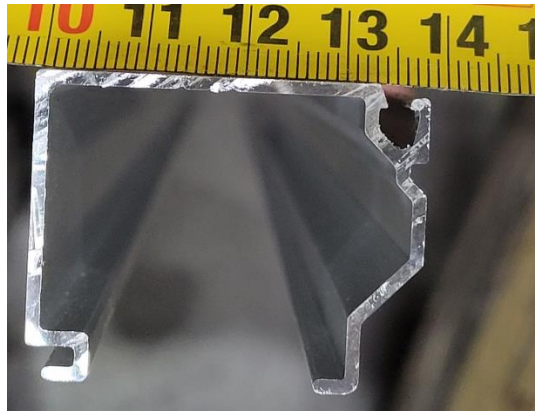
Photo No. 6
Glazing stop profile

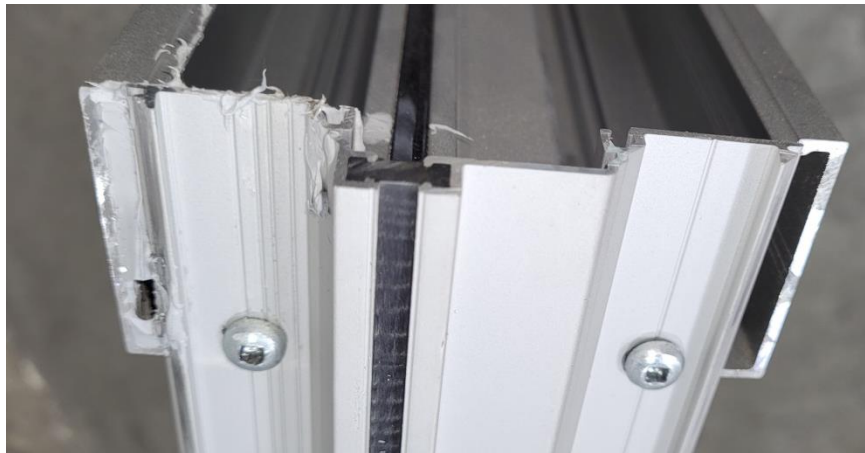
Photo No. 7
Corner joint fasteners for one side of vertical mullion

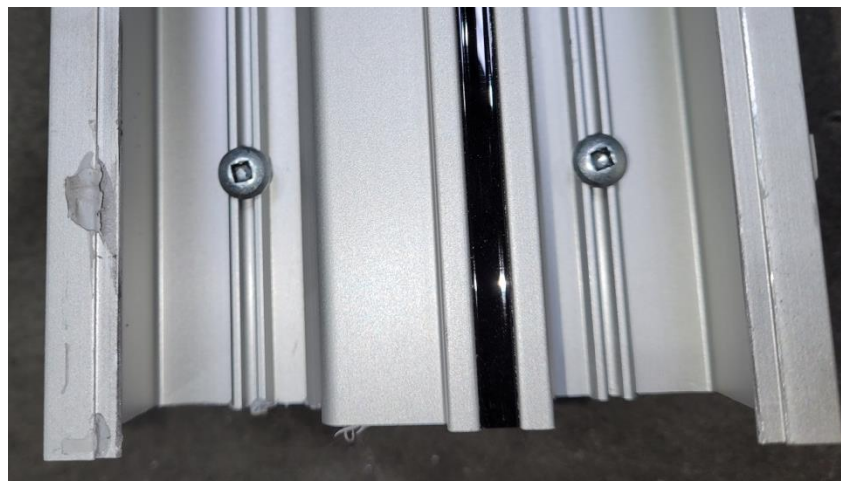
Photo No. 8
Corner joint fasteners for head and vertical mullion

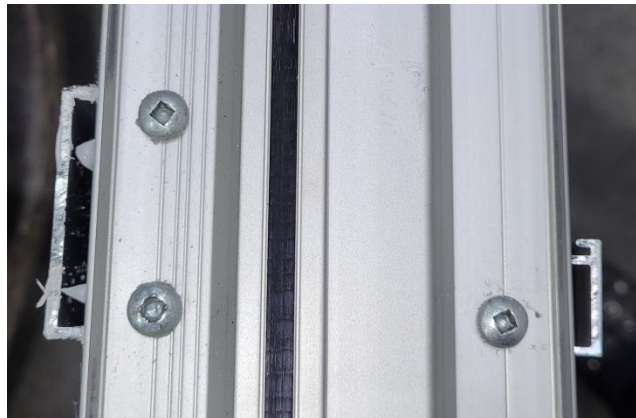
Photo No. 9

Corner joint fasteners for horizontal mullion and sill

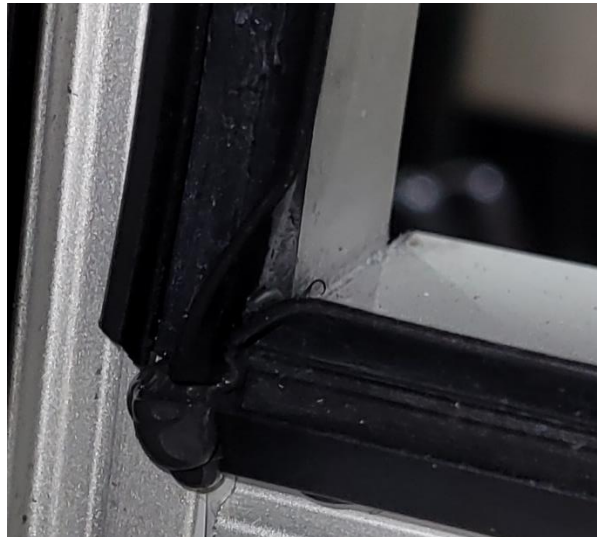
Photo No. 10

Glazing gasket with silicone at corners

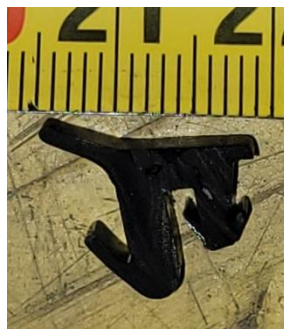
Photo No. 11

Glazing gasket – Interior and exterior side

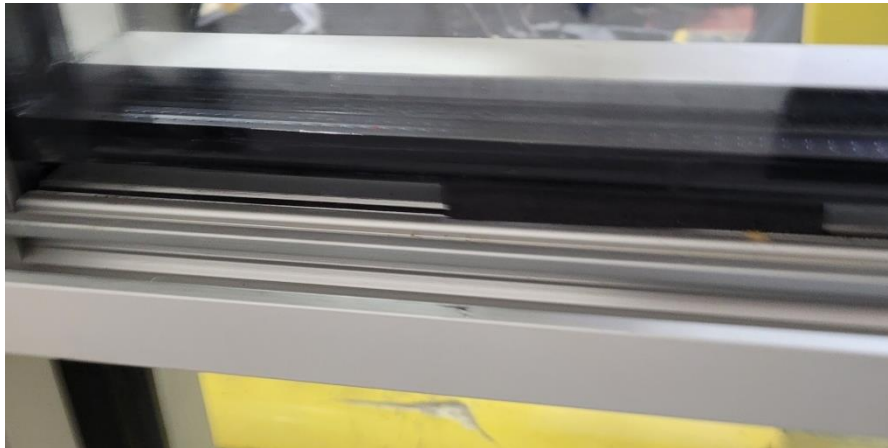
Photo No. 13
Setting block location

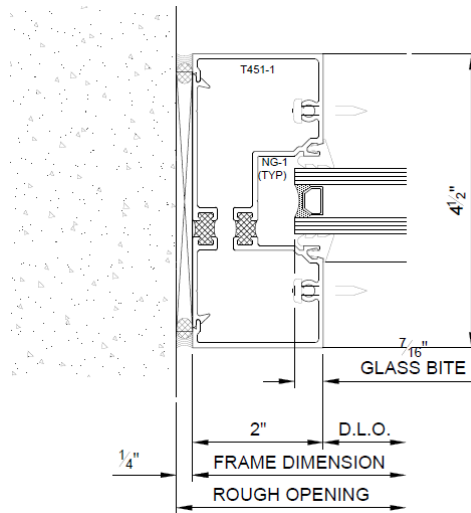
1 STOREFRONT JAMB
D2

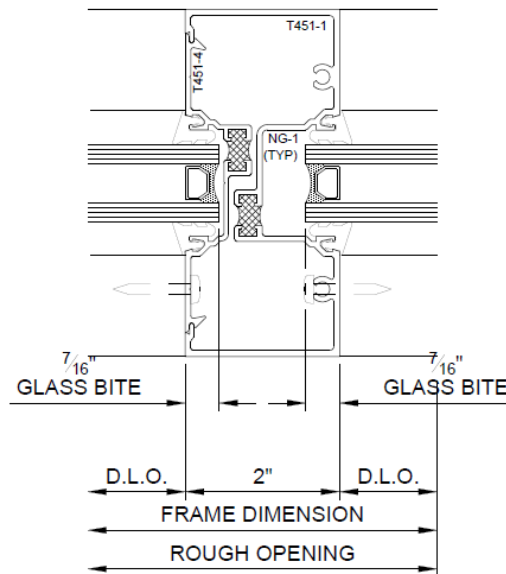
2 VERTICAL MULLION
D2
