TEST REPORT

Aluminum 3000 Series 4-Lite Fixed Combination Window

105479267COQ-001B

Intertek Building & Construction (B&C) was contracted by Acro Aluminum Inc. to perform testing on a 2058 mm (81.0") x 2210 mm (87.0") Aluminum 3000 Series 4-Lite Fixed Combination Window System in accordance with the following standard/specifications:

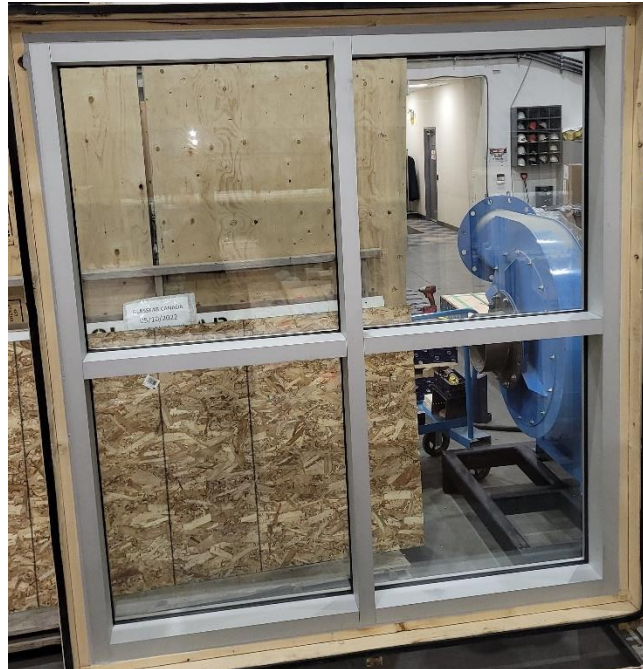
Photo No. 1

Aluminum 3000 Series 4-Lite Fixed Combination Window - Interior

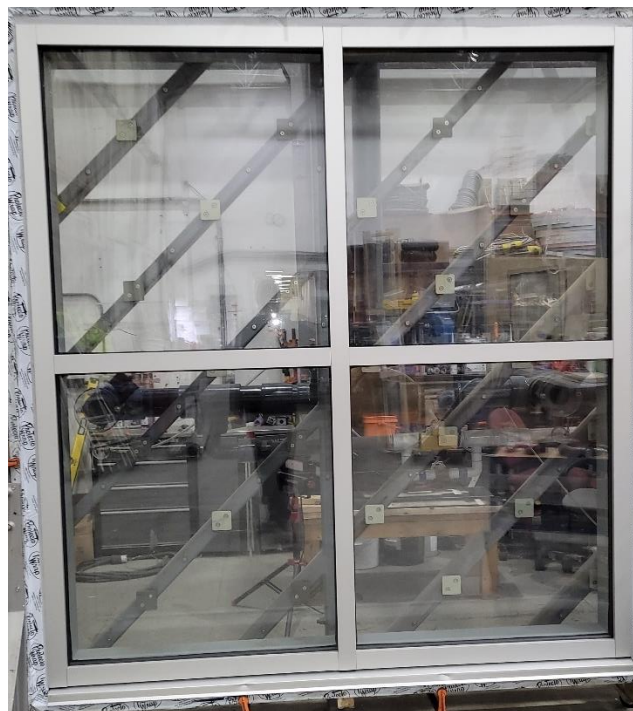
Photo No. 2

Aluminum 3000 Series 4-Lite Fixed Combination Window – Exterior

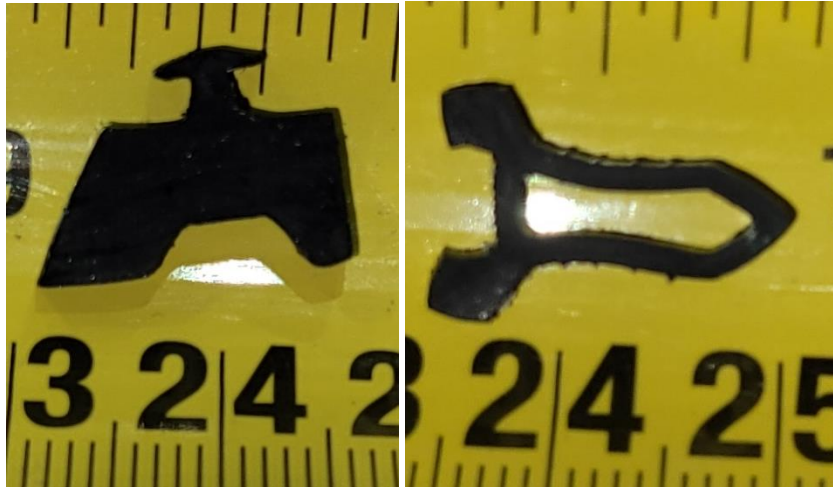
Photo No. 6 & 7
Pressure plate gasket profiles

| Glazing (4x) | <ul style="list-style-type: none">• IGU specification:<ul style="list-style-type: none">• 5 mm / 5 mm clear tempered with a 15 mm spacerbar.• Overall thickness, 25 mm (~1")• Laid-in, exterior glazed on top of a full perimeter glazing gasket, applied to the frame profile as 4 strips, one per length of frame profile. Silicone is used at each corner of the glazing gasket, extending approximately 178 mm (7") from the corner.• Exterior glazing gasket inserted into kerf of the pressure plate profile.• Glazing Blocks: 4x 102 mm (4") x 25 mm (1") x 6 mm (1/4") thick, neoprene setting blocks used to support the glass unit. 2x under the glass unit stacked two setting blocks high, approximately 191 mm (7-1/2") from either side.• Pressure Plates: Aluminum pressure plates are secured to the frame profile with 1/4" x 3/4" pan head bolts. 6x horizontal profiles are used, butted against the 3x full height vertical profiles. Horizontal profiles have 5x fasteners used, vertical profiles have 10x fasteners used. Pressure plates include 2x glazing gaskets as noted above, and a centre gasket. An aluminum beauty cap profile is snapped over each corresponding length of pressure plate. |

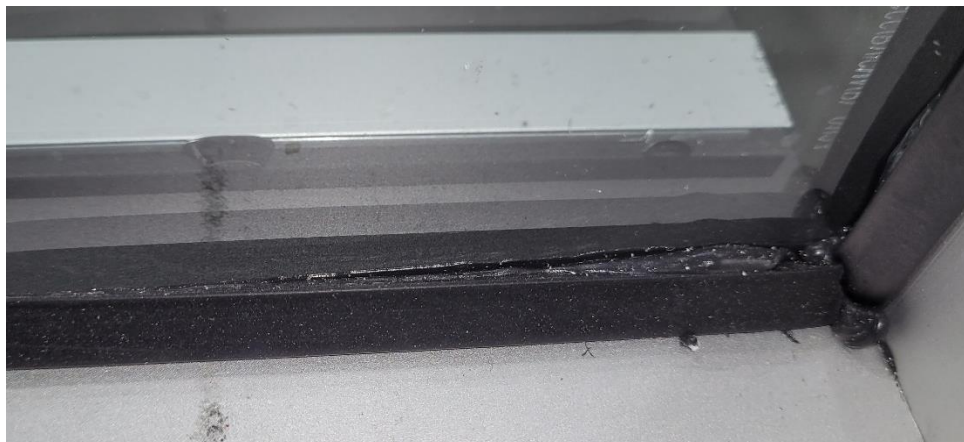
Photo No. 9
Interior glazing gasket with silicone at corners

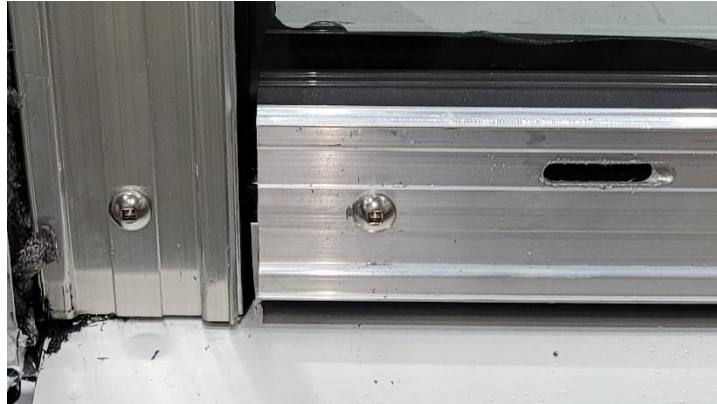
Photo No. 10
Pressure plate joint, bolts and drain slot

| Drainage | <ul style="list-style-type: none">• Each horizontal pressure plate has 2x drain slots, approximately 38 mm (1.5") x 5mm (0.20") centered approximately 89 mm (3-1/2") from either end.• Each horizontal beauty cap has 2x 7 mm (1/4") diameter drain holes through the bottom edge, approximately 191 mm (7-1/2") from either end of the profile. |

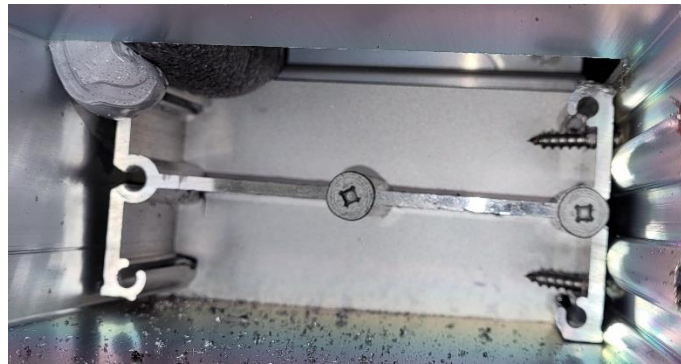
Photo No. 11
Aluminum shear block secured to the mullion

| Vertical Mullion | <ul style="list-style-type: none">• One continuous vertical mullion• Corners: Butt joined and secured with the use of an aluminum corner block on each side of the mullion. Each corner block is secured to the mullion with 2x #8 x 2-1/2" pan head self-tapping screws. The joining horizontal head or sill profile slides over the corner block and then is secured in place with 2x #8 x 1" flat head screws from the exterior side. A plastic spacer block is used on the exterior side of each corner joint, and the joint is sealed with silicone.• Reinforcement: None |

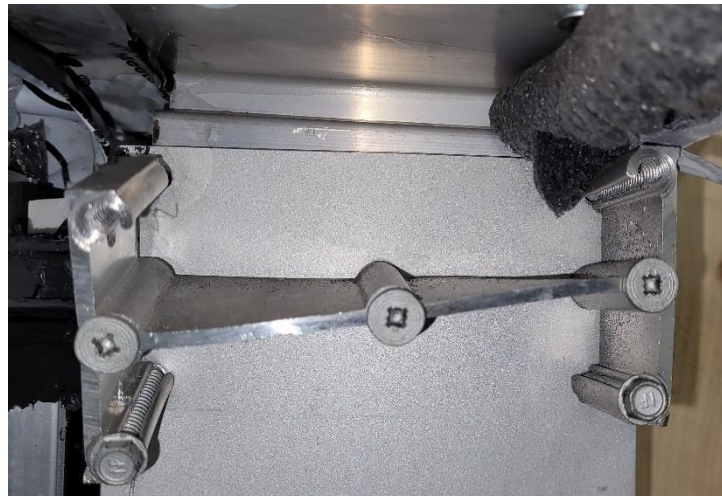
Photo No. 12
Aluminum shear block secured to the jamb

| Frame | <ul style="list-style-type: none">Material: AluminumCorners: Butt joined and secured with the use of an aluminum corner block. The corner block is secured to the vertical jambs with 3x #8 x 2-1/2" pan head self-tapping screws and 2x #10 x 2-1/2" self-tapping Torx screws. The joining horizontal profile slides over the corner block and then is secured in place with 2x #8 x 1" flat head screws from the exterior side. A plastic spacer block is used on the exterior side of each corner joint, and the joint is sealed with silicone.An aluminum drip cap profile was used along the sill of the assembly, secured to either side of the assembly with 1x #8 x 3/4" flat head self-tapping screw.Reinforcement: None |

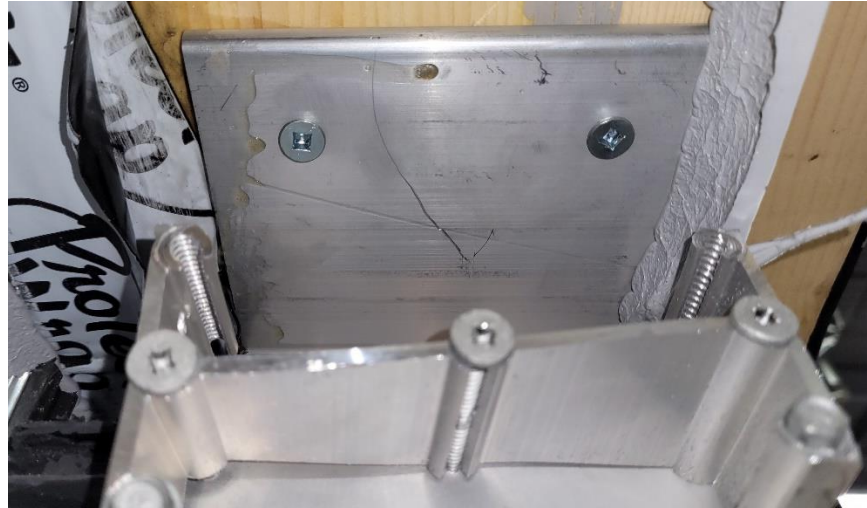
Photo No. 13

Aluminum L Bracket secured to buck and installed into jamb

| Installation | <ul style="list-style-type: none">Test Buck: 2x6, #2 & better spf, box w/ 2x12, #2 & better spf, cladding, butt joints secured with 2x #8 x 3" deck screws. The 2x12 clad was also butt jointed together with 4x #8 x 3" deck screws and secured to the 2x6 with #8 x 3" flat head screws at least at every 305 mm (12"). The buck was lined with a peel & stick membrane.<ul style="list-style-type: none">Specimen to Buck: An aluminum installation angle is used to install the interior side of the sill to the 2x6 portion of the test buck, approximately 76 mm (3") x 25 mm (1") x 3.5 mm (0.13"). The angle is secured to the test buck with #12 x 3" flat head screws, spaced approximately 406 mm (16") o.c. , and the angle is secured to the window sill with #8 x 3/4" flat head self-tapping screws, approximately 406 mm (16") o.c. The vertical mullion and each jamb was supported at the head with the use of an Aluminum "L" or "T" shaped brackets, approximately 102 mm (4") tall, inserted into the hollow cavity of the vertical profile, and secured to the head of the buck with 4x #12 x 1/2" flat head screws for the mullion, and 2x #12 x 1/2" flat head screws for the jambs.Silicone was used to seal all joints of the test buck as well as the rough opening of the buck, full perimeter around the interior side. The exterior side has silicone along the jambs and head, and the peel & stick membrane is used to seal the exterior side of the installation angle along the sill. |

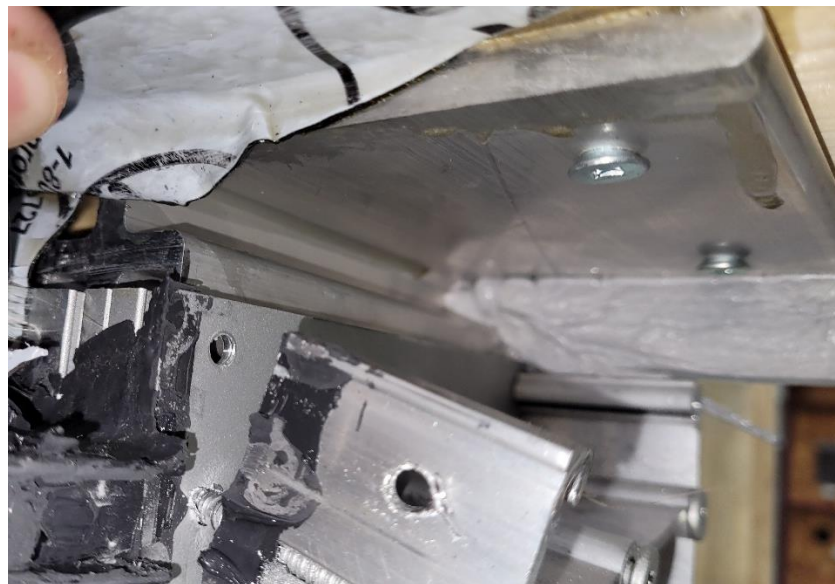
Photo No. 14

Aluminum installation L bracket for the jamb

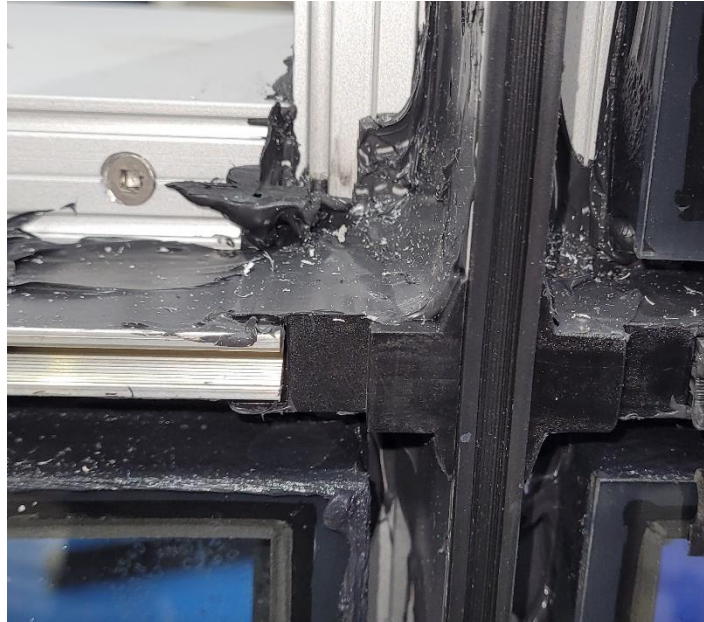
Photo No. 15
Mullion joint with spacer blocks

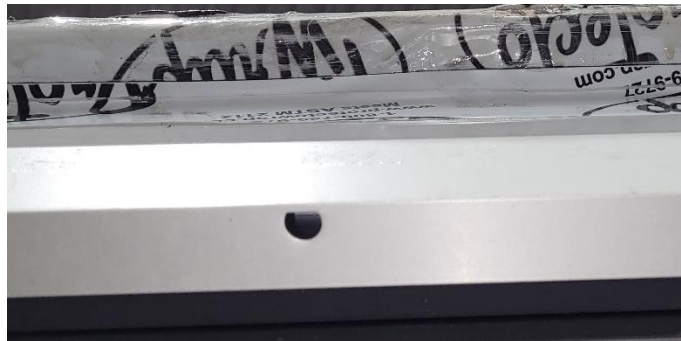
Photo No. 16
Beauty cap drain hole

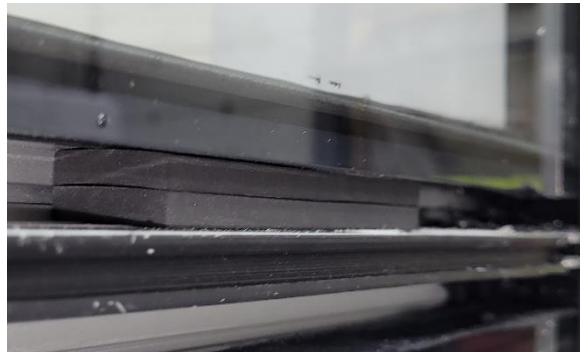
Photo No. 17
Setting blocks
